SERVICE BULLETIN

KAIR10003 – BioniX APR Stop Rings

LANAS 26 October 2010

SUBJECT: Wear on the rear ring maintaining the hang bracket.

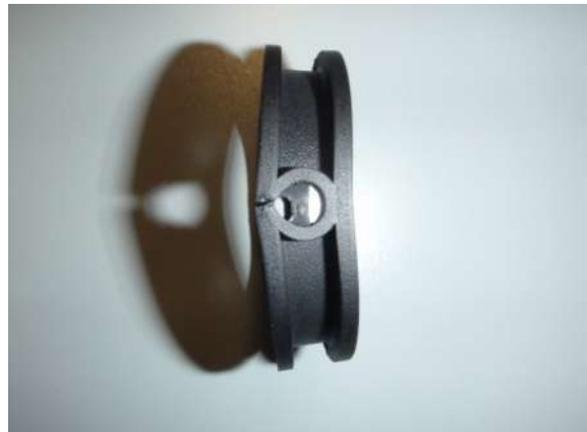
Distortion or possible crack of the rear ring retaining the hang bracket on the keel. In case of rupture, wear of the nylon of the sleeve and aluminum of the hang bracket against the head of the bolt and the securing screw of the ring.

Shocks during taxi, quality of material.

Cracked Ring

Check the ring during pre-flight visits.

In case of bend or crack, stop flights and replace the rear ring with the new model, reinforced with fiberglass, provided by the factory upon request. Please contact the factory for this replacement.

At 300 hour overhaul, always replace the rear ring with the new model.
