SERVICE NOTE

Date : 08 April 2013

- Modification of the rear APR rings and keel tube.

- All BioniX and NuviX

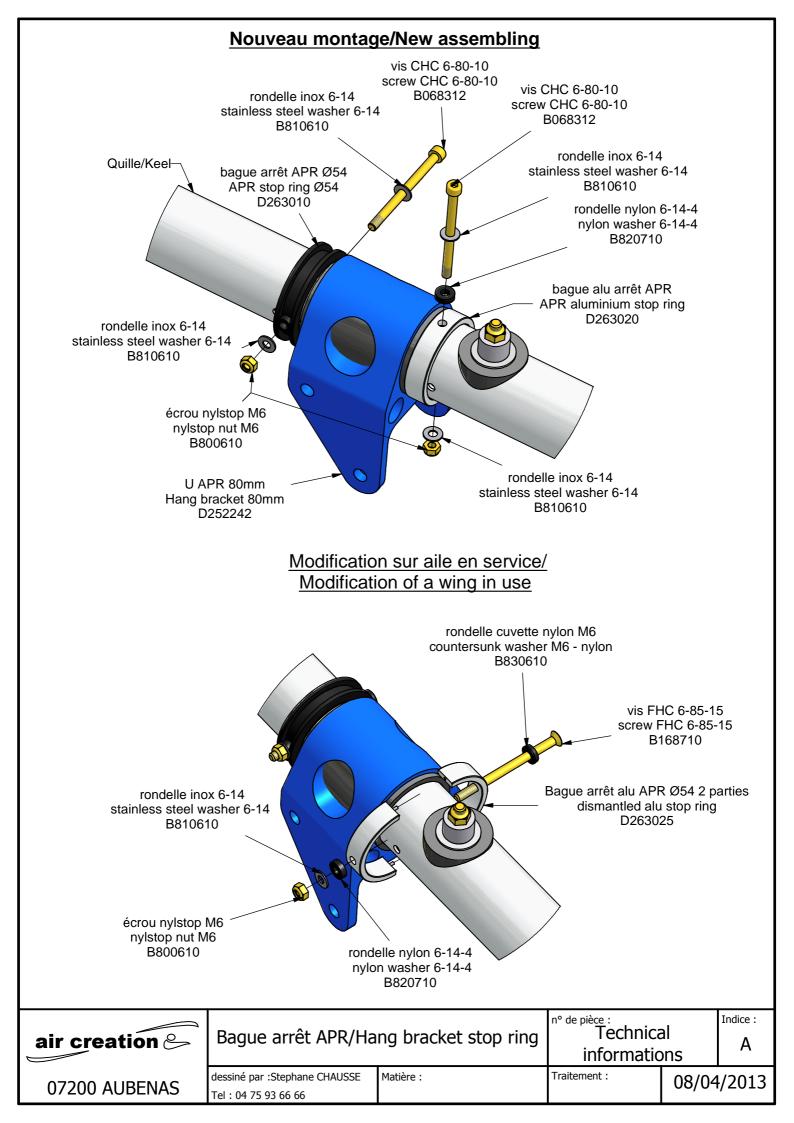
- The rear APR rings of nylon fibers are replaced by aluminium ones on all NuviX, BioniX 13 and 15.
- The drilled Ø6 hole that secures the rear ring in the central position on the keel is henceforth tuned at 90° from the other positions. With the APR in standard middle position, the screws of the rear locking ring is thus perpendicular to the one of the front ring. The screws used are identical on the 2 rings but different from the front assembly (see drawing of the new assembly).

For wings in service, it is recommended to replace the rear ring by the model in aluminium.
We provide for this purpose an aluminium ring in two parts that allows for the installation without dismounting the keel.

The replacement procedure is as follows: remove the push-pin from the swan neck of the front lower longitudinal cables at the nose of the wing to slacken these cables.

- Unscrew the screw that secures the front ring and slide the latter as well as the APR towards the nose of the wing. Once the front ring is no longer in contact with the APR, remove the screw that maintains the rear ring and using cutters section the nylon ring at the level of its securing holes in order to detach it from the keel. Put the new aluminium 2-part ring in place respecting the direction of the assembly, then push back the APR against it and reassemble the front ring. Retention the front lower longitudinal cables at the nose of the wing. (see drawing of the modified assembly for wing in service).
- During the 300 hour overhaul, the replacement of the rear rings by the aluminium model is mandatory, if it has not yet been done.
