SERVICE NOTE

Date: 21 September 2011

- Maintenance of engine mount 912 (n°E305020) of trikes arv Tanarg and LST Skypper

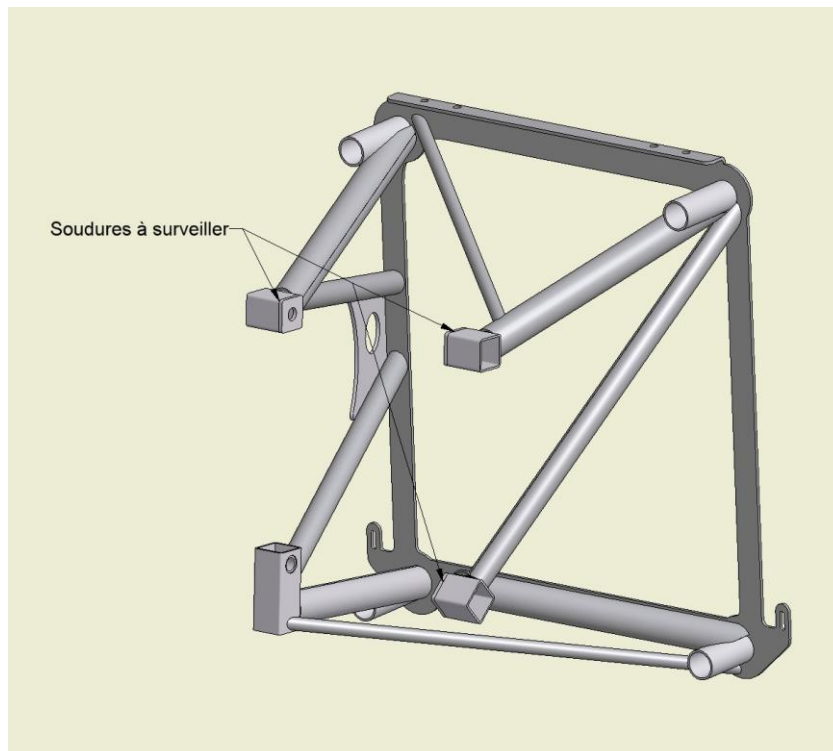
The engine mount is an essential part that requires careful attention. On one trike, equipped with a 912 engine, a crack in the soldering between one of the holding plates and its rectangular tube.

Soldering areas to be checked

- You are requested to check this area carefully before your next flight.
- The checking of this particular point should be included in the 25-hour inspection visits.
- In case of cracking, do not fly and contact the factory for the replacement of the engine mount.
