NOTE OF INFORMATION

- Monitoring of the upper beam (No. E305930) of arv Tanarg tricycles.

- All versions of the arv Tanarg tricycle.

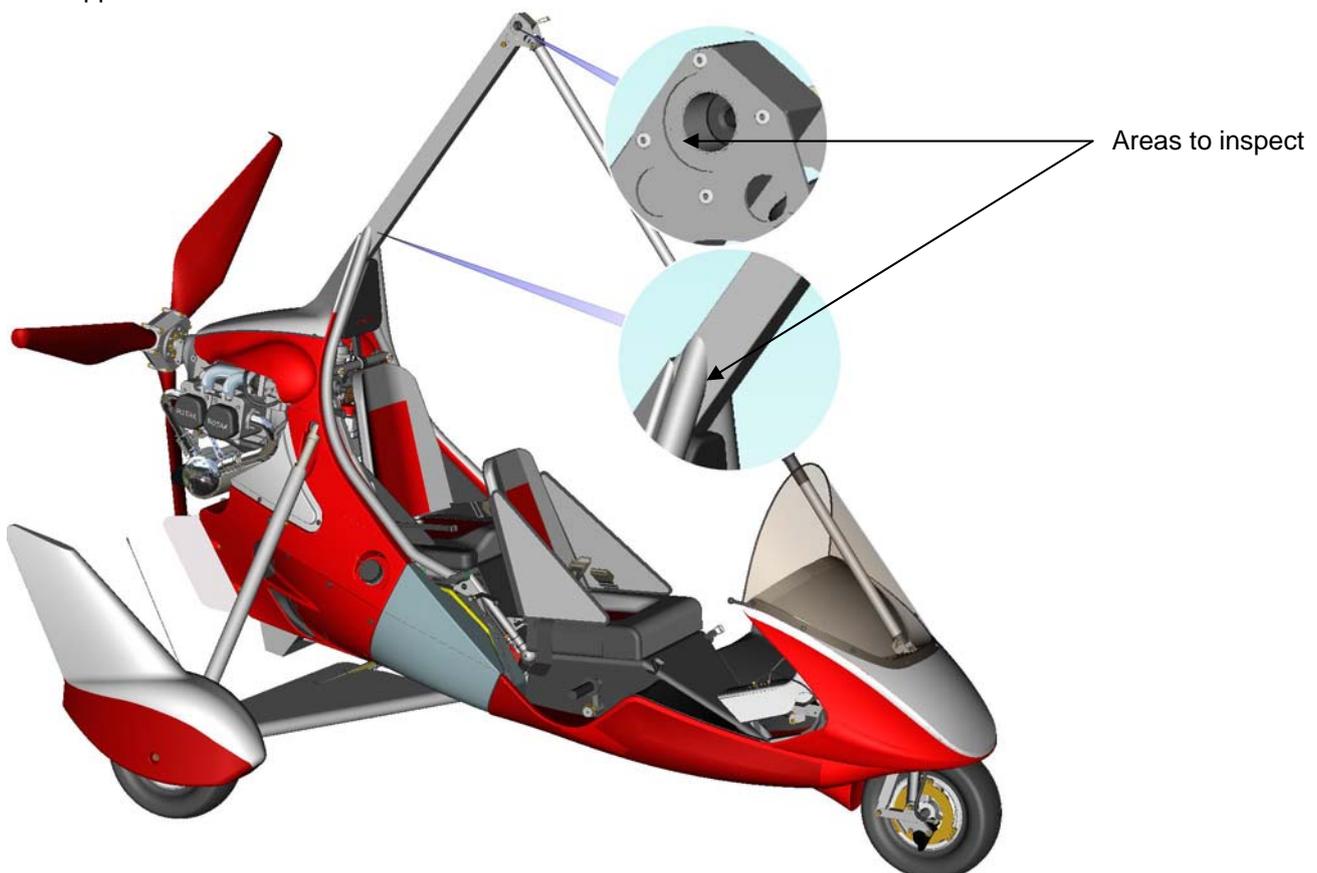
The upper beam of the Tanarg is an essential part that requires special attention. A visual inspection must be performed systematically before each flight, especially at the base of the rectangular beam where the beam tubes connect and at the point where the wing is attached (picture below).

Under harsh conditions of land use and parking in the wind, abnormal stress can be generated leading to an increase of fatigue; cracks may appear and parts may become unsoldered. In this case flight must be suspended and the part replaced.

The area of attachment of the wing should be inspected carefully when checking the tricycle every 100 hours. The nylon bushings (E134010) must be removed in order to monitor the condition of the welds of the tube supports.
